Impact of storage induced outgassing organic contamination on laser induced damage of silica optics at 351 nm

Abstract: The impact of storage conditions on laser induced damage density at 351 nm on bare fused polished silica samples has been studied. Intentionally outgassing of polypropylene pieces on silica samples was done. We evidenced an important increase of laser induced damage density on contaminated samples demonstrating that storage could limit optics lifetime performances. Atomic Force Microscopy (AFM) and Gas Chromatography -Mass Spectrometry (GC-MS) have been used to identify the potential causes of this effect. It shows that a small quantity of organic contamination deposited on silica surface is responsible for this degradation. Various hypotheses are proposed to explain the damage mechanism. The more likely hypothesis is a coupling between surface defects of optics and organic contaminants.

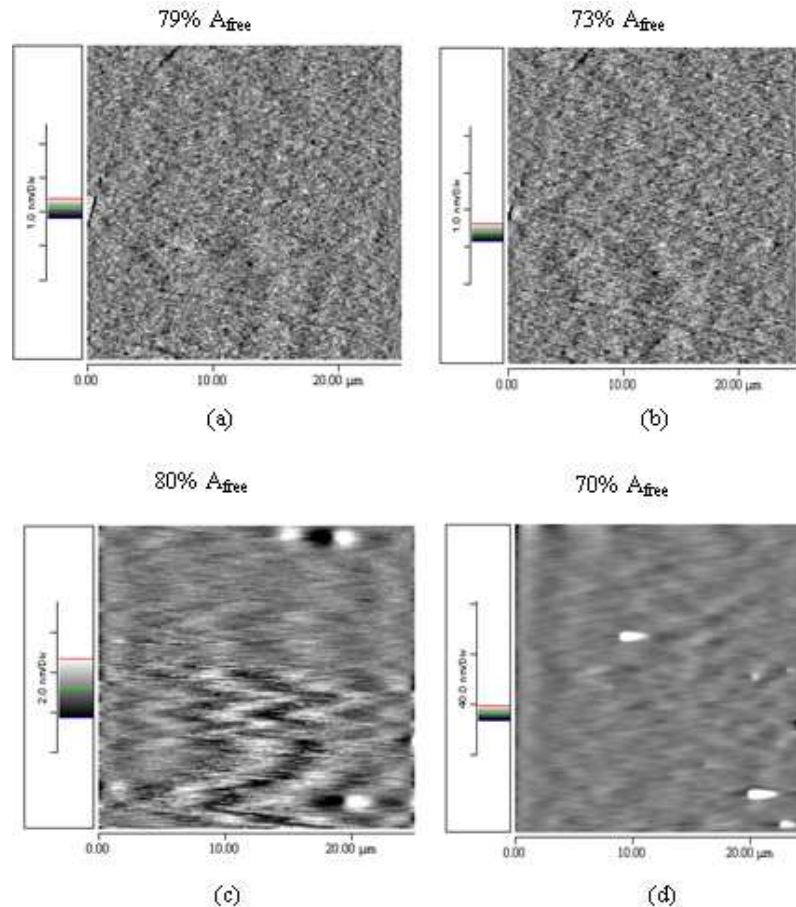
Fig. 7. AFM picture of bare silica samples after cleaning (a and b) and after contamination (c and d) for different set point amplitude values

of pictures can also be attributed to the fact that the approach of the tip is not effective, complementary experiments were performed. AFM images of clean silica samples and contaminated ones were made with different set point amplitude values (Fig. 7). For 79% or 73% of the free amplitude, respectively images a and b of Fig. 7, clean bare silica surface is well distinguishable. We found the same root mean square roughness certified by the manufacturer. On contaminated samples, for low forces (80% of the free amplitude, Fig. 7c) the tip generates streaks and for higher force (70% of the free amplitude, Fig. 7d), the silica surface is still not apparent. Indeed, at the end of the measure, after the withdrawal step, the natural oscillating amplitude of the tip has decreased of about 20 nm and a shift of natural frequency was noticed. In normal conditions, the natural oscillating amplitude and frequency come back to the ordered values at the end of the withdrawal.

In a similar experiment, imaging droplets, Pompe [20] noticed various behaviors for trace and retrace signal as well as amplitude and resonance frequency shifts of the cantilever, depending on the chosen set point amplitude value. It was attributed to the instability of the cantilever motion against the attractive capillary forces. For small set point, a permanent liquid bridge between the tip and the liquid drop is formed. This liquid bridge is likely to alter our AFM measurements.
