Impact of two CO₂ laser heatings for damage repairing on fused silica surface

Abstract: CO₂ laser is an interesting tool to repair defects on silica optics. We studied UV nanosecond laser-induced damage in fused silica after CO₂ laser heating. The localization of damage sites and the laser damage threshold are closely related to stress area in silica induced by heating. By applying a suitable second laser heating, we managed to eliminate the debris issued from redeposited silica and to modify the stress area. As a consequence, a significant increase of laser resistance has been observed. This process offers the possibility to improve damage repairing sufficiently to extend the lifetime of the silica components.

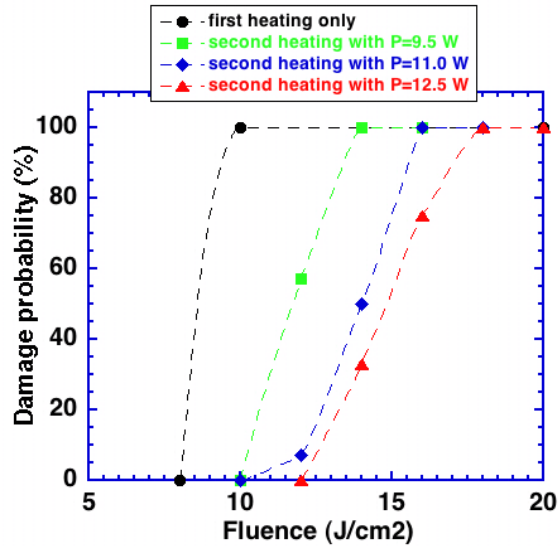
Fig. 5. Laser damage probability as a function of the fluence of irradiation at 355 nm. Before the damage test, each site had been heated by a first CO₂ laser (1 s, 0.6 mm at 1/e² and 5.5 W), then different power levels were used for the second heating (1 s and 1.4 mm at 1/e²). Each color corresponds to a value of power used for the second heating.

It has been observed [21] that fractures lead to damage at fluence as low as 5 J/cm². With our parameter of mitigation, each previously damage site undergoes fluence of 8 J/cm², but new damage sites were initiated with a fluence of 10 J/cm², for all of them. As expected, these fluences increase significantly when operating a second heating before laser damage test. The most important consequence is that a fluence greater than 12 J/cm² is needed to initiate damage if the second heating is realized at a power of 12.5 W. This work makes obvious the contribution of a second heating below the mass ejection to increase the UV laser resistance.

Irradiations, in which the Nd: YAG laser beam was directed to areas of high relative retardation previously measured by the polariscope, were repeated on series of 20 identical sites to evaluate a laser damage probability. With this experimental procedure, sites where damage was repaired by one heating at power of 5.5 W during 1 s with a beam diameter of 0.7 mm at 1/e², are compared with sites where damage was repaired and then heated a second time with a larger beam. For this last point, powers of 9.5 W, 11.0 W or 12.5 W were used during 1 s with a beam diameter of 1.4 mm at 1/e². Figure 5 compares the probability of damage for the different cases.
